CMS
BARREL MUON
DT CHAMBERS

News on
Tools, Tests,
Start of Assembly
at Aachen;
Services, Safety,
Cooling, ISR Hall

Hans Reithler
010425

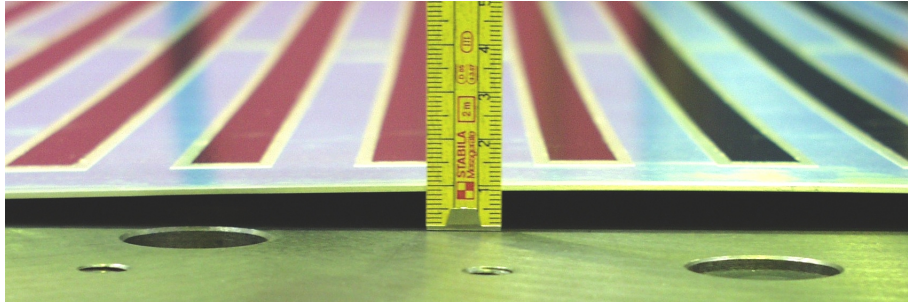
Some examples of non-conformities of finished plates
(observed on first plates for 1 MB1, arrived 010406) :

Difficult
gluing

- Plates bent at 1 cm/m level! - outside tolerances (Known; are test. Which is role of this first assembly? Tool test under extreme conditions? Debugging of assembly?)

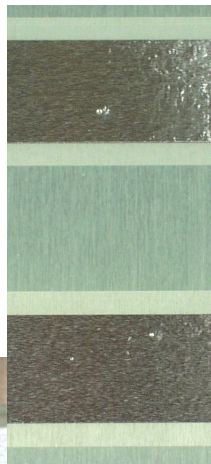
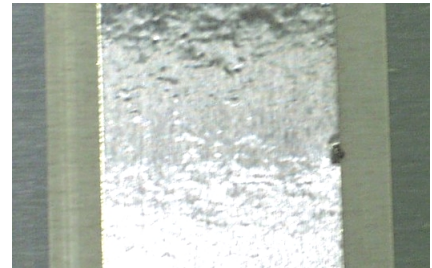
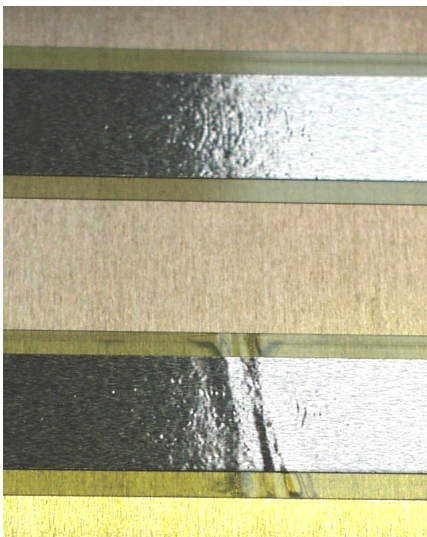
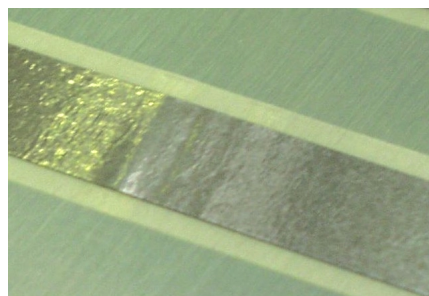
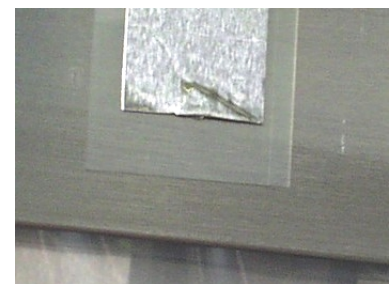
- Dangerous defects: points sticking out (1-4) and Mylar+Al tape sticking out by ~ 1 mm ! (5, 6) are likely to give HV problems; two or more Al layers (7) would compromise endplug space and position.

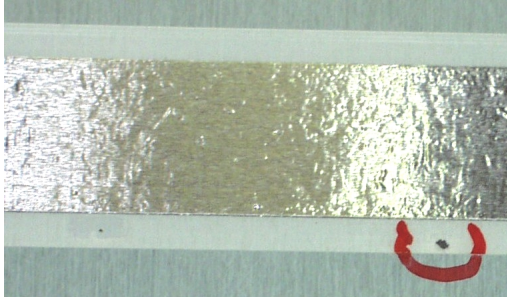
- *Dirt under Mylar strip. Noticed and marked at plate production site (left); noticed at chamber assembly site (right). Dangerous or not?*

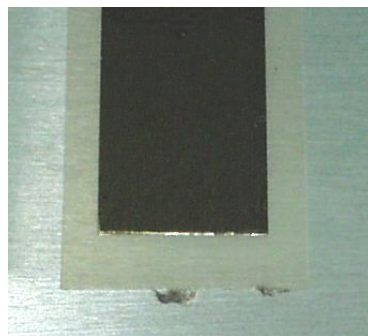
- *Glue at border. This case is probably not causing any trouble.*

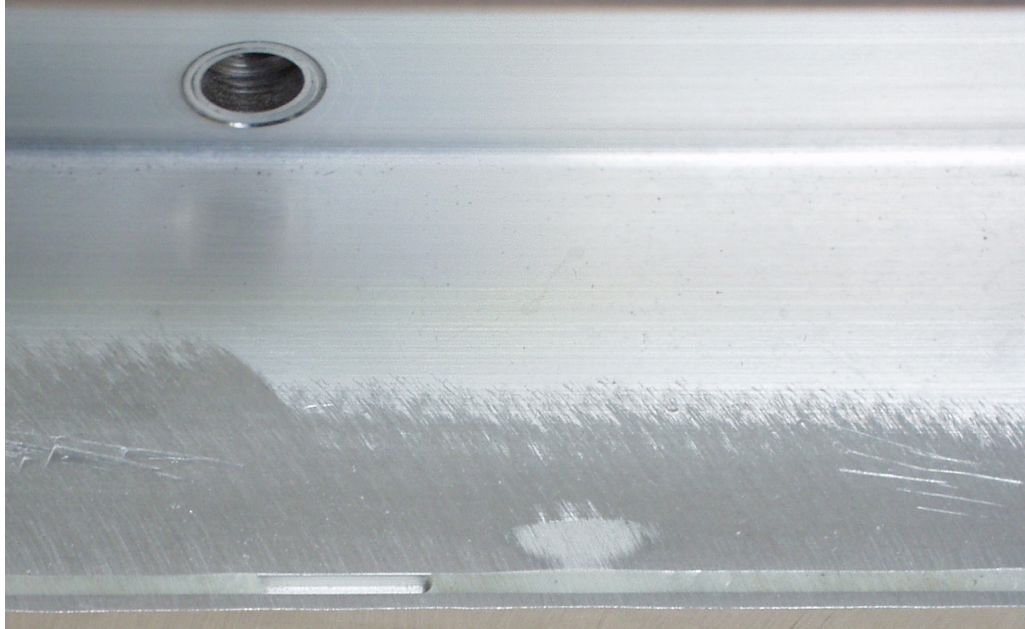
Quality control of 2 honeycomb panels received recently:

Visual control: Groove is full of glue. Coarse grinding used to remove glue from border left visible traces, **too sharp edges** and **much dirt in lateral channels**. **Metallic pieces** (from inserts) falling out of channels.

PANEL 1:	PANEL 1:	conclude:
Thickness(*) (128.0±0.5 mm)	128.2 - 129.0	128.3 - 129.5	not o.k.
Width 1	1923.3	1922.9	o.k.
Width 2	1923.2	1923.1	o.k.
Diagonal difference (≤ 3 mm)	1	1	o.k.

(*) Is height above flat plane of table. Measured at grid of 3 x 3 points, for both faces of the honeycomb. One face nearly flat, the second face is bad.

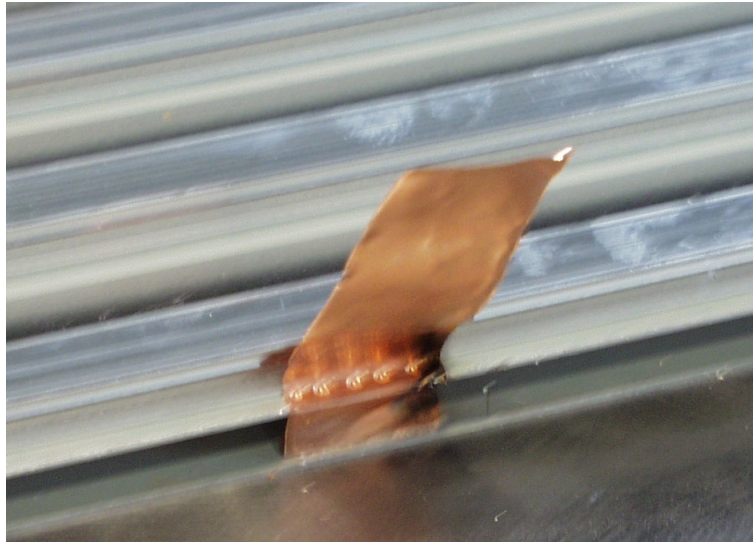
*Lateral strips: welding on Al plate **surface** works fine (left points), while welding on **non-flat edge** does not work (right point, dark). **Use point welding on plate face, not edge.***

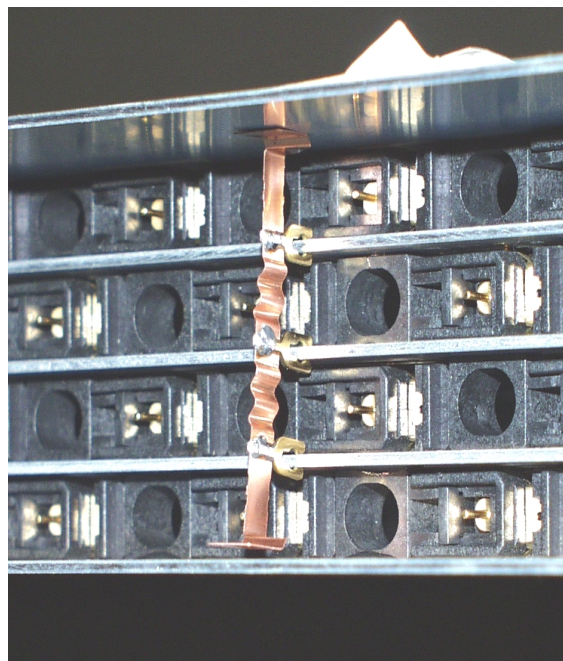
*Contact spring: Alloy used is not adequate for point welding. **Use conductive glue** at top and bottom plates.*

P.S.: Short after this meeting, M. Degiorgi has demonstrated that and how also this contact spring can be correctly point welded.
