CMS
BARREL MUON
DT CHAMBERS

News on
Tools, Tests,
Start of Assembly
at Aachen;
Services, Safety,
Cooling, ISR Hall

Hans Reithler
010425

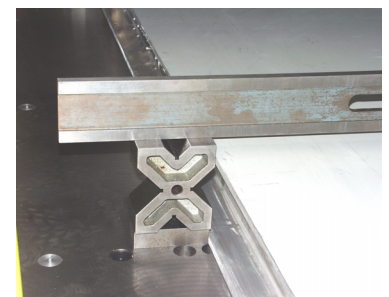
Visual control: Groove is full of glue. Coarse grinding used to remove glue from border left visible traces, **too sharp edges** and **much dirt in lateral channels**. **Metallic pieces** (from inserts) falling out of channels.

PANEL 1:	PANEL 1:	conclude:
Thickness(*) (128.0±0.5 mm)	128.2 - 129.0	128.3 - 129.5	not o.k.
Width 1	1923.3	1922.9	o.k.
Width 2	1923.2	1923.1	o.k.
Diagonal difference (≤ 3 mm)	1	1	o.k.

Ruler, to measure at center.

(*) Is height above flat plane of table. Measured at grid of 3 x 3 points, for both faces of the honeycomb. One face nearly flat, the second face is bad.
